MUNITIONS STORAGE SITE 2 NEAR HENG-YANG, CHINA

CIA/PIR 63044

DATE APRIL 1966

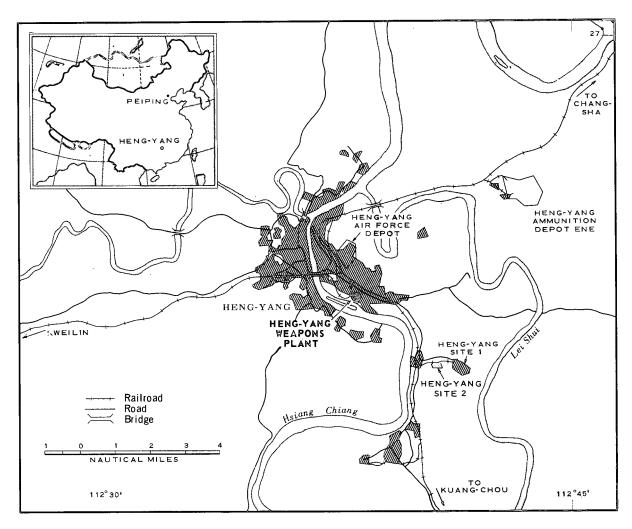
FIGURE 1.

A previously identified munitions storage site 1/ is located at 26-50-30N ll2-40-20E, 4.5 nautical miles (nm) southeast of the center of Heng-yang, China and 3 nm southeast of the Heng-yang Weapons Plant (BE 4/ (Figure 1). The site is located adjacent to Heng-yang Munitions Storage Site 1, 2/3/ and both sites are served by the same rail spur (Figure 1).

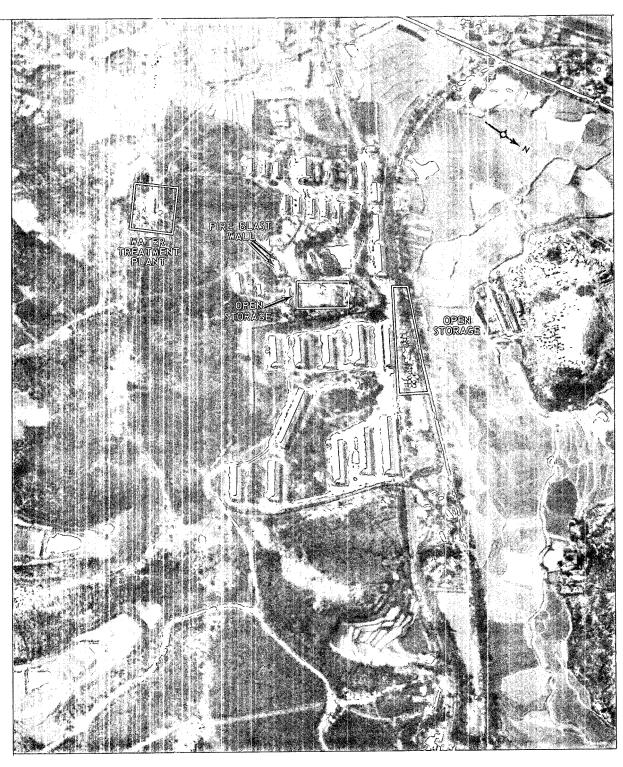
FIGURE 2. MUNITIONS STORAGE SITE 2 NEAR HENG-YANG, CHINA DATE OF PHOTOGRAPHY:

Storage facilities at the site include 11 warehouses, 2 transshipment warehouses (Buildings 5 and 11, Figure 3), 2 storage/service buildings (Buildings 14 and 15, Figure 3) and 2 open storage areas (Figure 2). Most of the buildings have modified hip roofs with ventilators at each end. Buildings 11, 14 and 15 differ in that they have standard gable roofs and no apparent ventilation devices. The 5 monitor ventilators visible on Building 4 provide additional ventilation for this warehouse.

The items observed in the 2 open-storage areas are dissimilar in appearance. Rows of small unidentified objects are visible in Area A, but large rectangular crates or canvas-covered objects can be seen in Area B (Figure 2).

The housing and administration area is located just inside the entrance to the site (Figure 3). Facilities in this area include 2 administration buildings, 7 barracks, 1 combination auditorium and messhall, 1 water treatment plant, an athletic field, and several other buildings. One building (Item C, Figure 3) is divided into 3 sections by fire/blast walls which are seen protruding above the roof line (Figure 2).

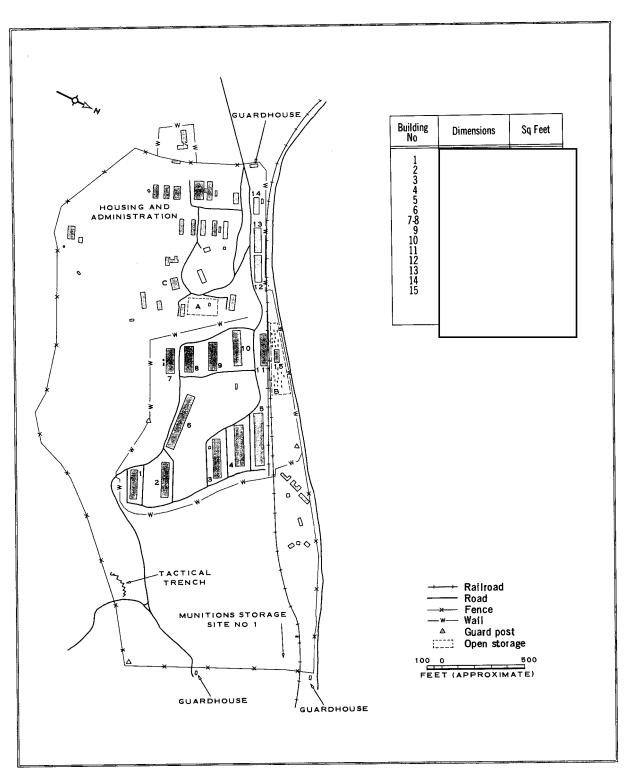
FIGURE 3. MUNITIONS STORAGE SITE 2 NEAR HENG-YANG, CHINA

The entire site is surrounded by a wall and fence combination, as indicated in Figure 3. Guardhouses are located at the road entrance to the site and at 2 entrances to Munitions Storage Site 1 (Figure 3). Guard posts are located at the 3 points indicated in Figure 3.
